ADVANCED OVERRUNNING CLUT; H TECHNOLOGY, (U)

DAAJ02-74-C-0028

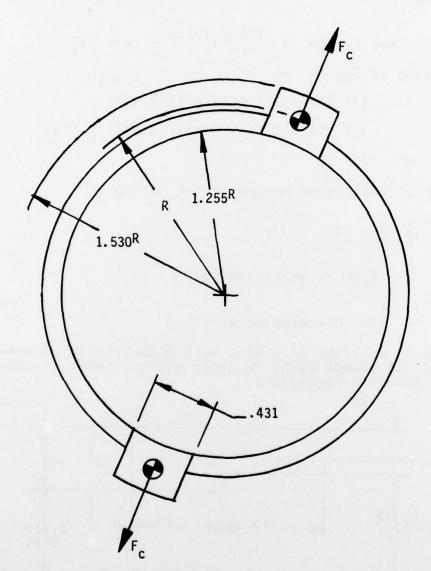
Figure A-1. Centrifugal Force on Cage, Ramp-Roller Clutch.

Under the action of centrifugal force, the cage of the ramproller clutch is subjected to two diametrically opposed forces as shown in Figure A-1.

Even though the loads are inherently balanced, at high speeds the centrifugal load, Fc, may become so high that the cage deflections exceed the clearance between the shaft journal and the cage. If this happens, the cage will be restrained from rotation, and the ramp-roller clutch will be unable to function properly in the overrunning mode.

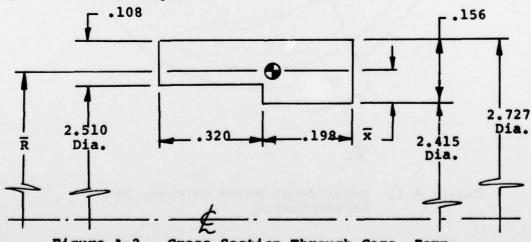
Figure A-2. Cross Section Through Cage, Ramp-Roller Clutch.

The cage is analyzed as a ring with diametrically opposed loads of 199 pounds each. A cross section taken through the cage is shown in Figure A-2.

Since the radial clearance between the cage and journal on the cam is .002 inch and the deflection is .0095 inch, the cage will hit the journal and pinch tightly, not allowing cage rotation.

To correct this situation, the lug was redesigned by removing weight from the lugs and by adding a stiffening ring to the outside of the cage. The redesigned lug is shown in Figure A-3.

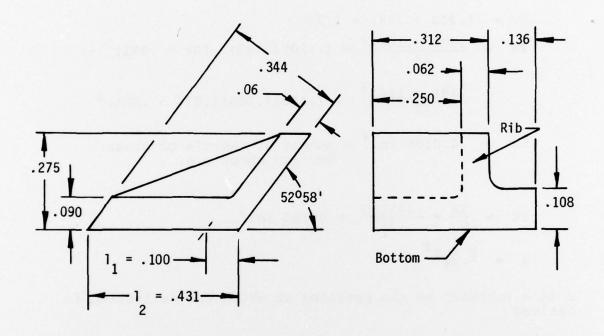
Figure A-3. Redesigned Lug of Cage, Ramp-Roller Clutch.

Vrib = $.00531 \text{ in.}^{3}$
Vlug = $(.136)(.431)(.108) = .00633 \text{ in.}^{3}$
 ρ = $.29 = \text{density of steel}$
Wh = $.29 \left[.00801 + .00517 + .00531 + .00633 \right]$
Wh = $.00720 \text{ lb}$
Fc = $199 \frac{\text{Wh}}{\text{WL}} = 199 \frac{.00720}{.0126}$
Fc = $114 \text{ lb} = \text{centrifugal force on redesigned}$

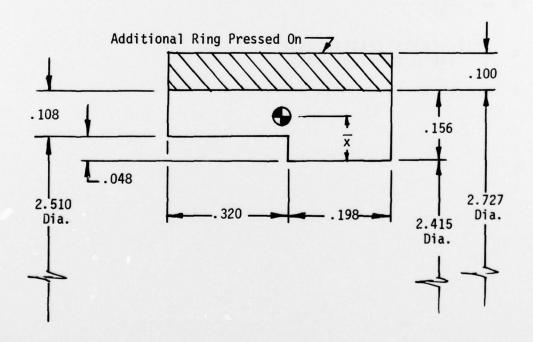
Figure A-4. Redesigned Cage With Press-Fitted Ring, Ramp-Roller Clutch.

Since the radial clearance between the cage and the journal on the cam is .002 inch, the cage will be free to rotate at 20,000 rpm with the redesigned parts.

A cross section through the cage with the new press-fitted ring is shown in Figure A-4.

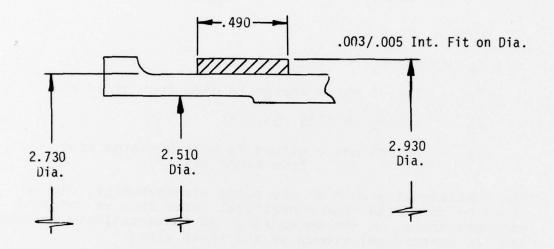
Figure A-5. Cross Section of Cage With Press-Fitted Ring, Ramp-Roller Clutch.

The following analysis is performed to determine if the ring will remain on the cage under the action of centrifugal force. Figure A-5 is a cross section of the ring pressfitted onto the cage.

Thus, the outer stiffening ring will grow by .0005 inch in diameter when rotating at 20,000 rpm, but it will remain on the cage because the minimum interference fit is .003 inch.

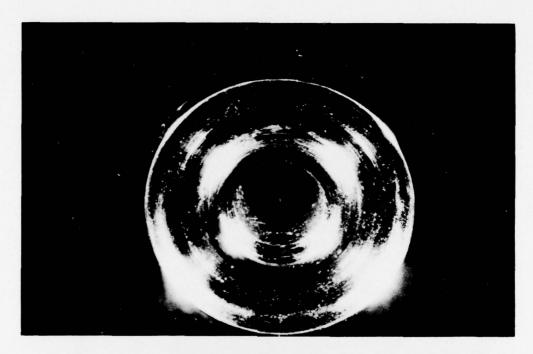
Figure 97. Ramp-Roller Clutch Roller, End Face Wear.

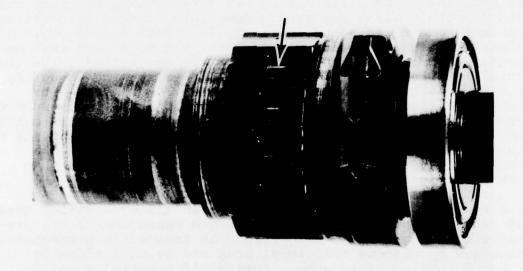
Figure 98. Roller Carrier After Differential-Speed Overrunning Test, Task I.

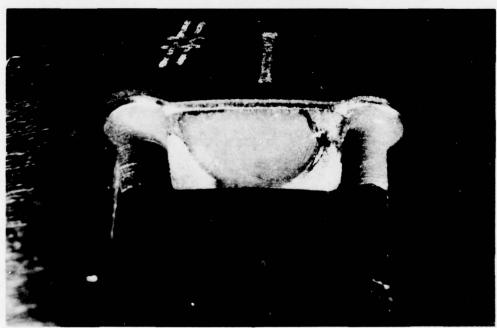
Figure 100. Roller End Wear and Wear in Corresponding Slot in Cage After Differential-Speed Retest.

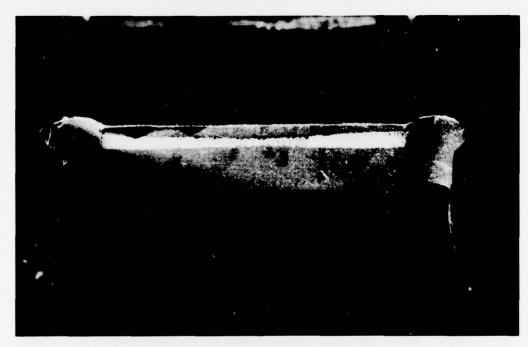
Figure 101. Typical Roller and Cage Slot Pattern After Differential-Speed Retest.

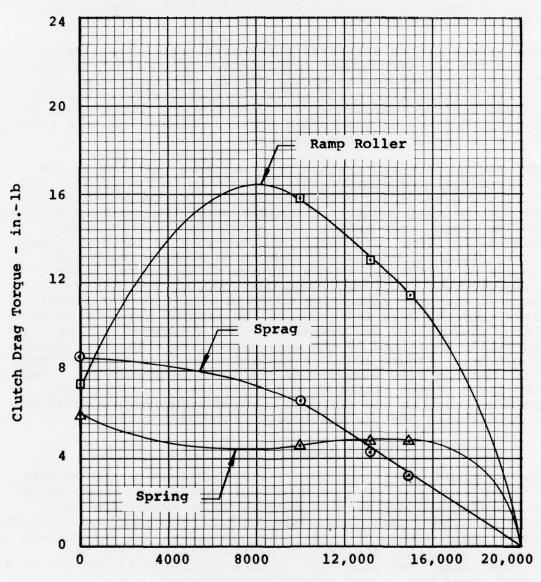
Figure 102. Drag Torque Versus Input Speeds
With Output at 20,000 rpm for Spring,
Sprag, and Ramp-Roller Clutches.

The ramp-roller clutch retest completed all overrunning tests of Task I. The results of drag-torque measurements are presented in Figure 102. Drag torque is induced in overrunning clutches by viscous frictional drag and by centrifugallyinduced rolling resistance. During differential-speed overrunning, when the input shaft speed is low, viscous effects are maximum because the difference in shaft speeds is maximum. As the input shaft speed increases, viscous friction decreases until the time when the input shaft speed is equal to the output. The opposite is true with rolling resistance. the input shaft is fixed, as in full-speed overrun, rolling resistance will have a fixed value. As the input shaft speed increases during differential-speed overrun, rolling resistance will increase because centrifugal force acting on the spinning components will increase. As with the viscous friction, rolling resistance is zero when the input and output shafts are rotating together in a locked position.

The spring clutch exhibited a relatively flat drag torque curve for all overrunning conditions. Centrifugal effects are not as important in the spring clutch, and therefore, the sum of the sliding resistance and viscous drag effects remains almost constant throughout the entire speed range. This is a typical feature of the spring clutch, which makes it a candidate for even higher speed operation.

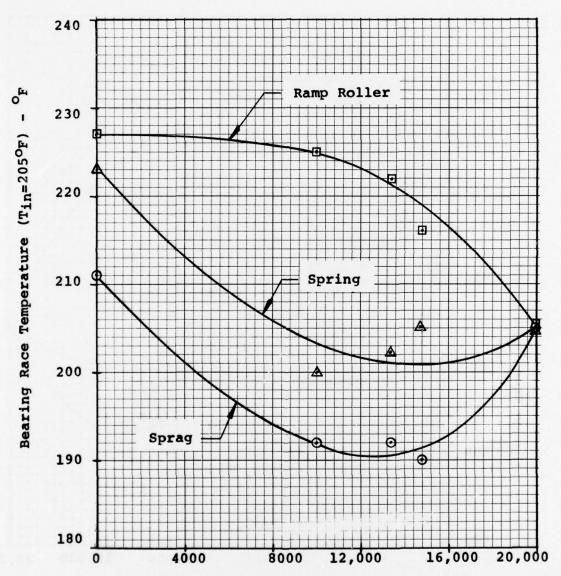
Figure 103. Clutch Race Temperature as a Function of Differential-Speed for Spring, Sprag, and Ramp-Roller Clutches.

The clutch race temperature is shown as a function of the differential-speed overrunning condition in Figure 103. The spring and the sprag clutches both exhibit temperature versus time curve that exhibits a minimum condition, whereas the ramproller clutch race temperature continues to decrease with increasing flow. It should be noted that in the spring and sprag clutches, the race temperatures between input shaft speeds of 10,000 and 15,000 rpm are below the oil inlet temperatures; i.e., the races were cooling the oil. This is because the heat generation in these conditions is actually less than the heat rejection by the natural means of convection, conduction, and radiation. The phenomenon can be partially explained by the decreasing drag with input speed functions (Figure 102). A similar situation was prevalent with bearing race temperature, as shown in Figure 104. Here, the sprag clutch exhibited the lowest race temperatures, perhaps owing to the straddle-mounted arrangement, which is a good design for the bearings of the sprag clutch.

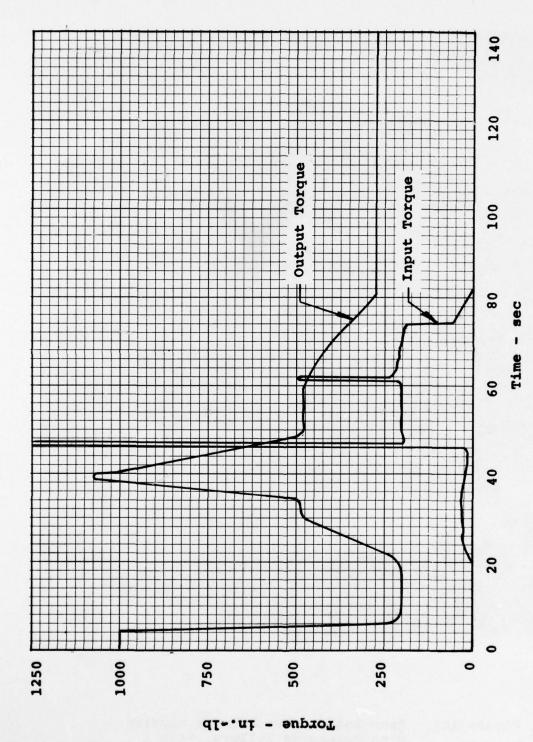
Figure 105. Torque Versus Time, Task I Turbine Dynamic Load Test, Ramp-Roller Clutch.

The second clutch to be subjected to the dynamic turbine test was the ramp-roller clutch. The test stand was started, and the flywheel was accelerated to 20,000 rpm at 400 horsepower to simulate flat-pitch rotor operation. This condition was held for 5 minutes. Next, the turbine speed was reduced to disengage the clutch, then accelerated to 100% speed; however, when the input speed was equal to the output speed, the clutch hesitated momentarily and then failed to pick up the load. The output speed continued to decay, while the input speed was held at approximately 20,000 rpm. At approximately 46 seconds after the disengagement, the clutch suddenly engaged. At the time of engagement, the input speed (turbine) was at approximately 18,900 rpm, while the output speed (flywheel) was at approximately 5900 rpm. Instantaneously, the input attempted to reach the same speed as the output and the clutch fractured.

Figure 105 is a plot of torque versus time. The torque spike at t = 46 seconds was at the moment of engagement.

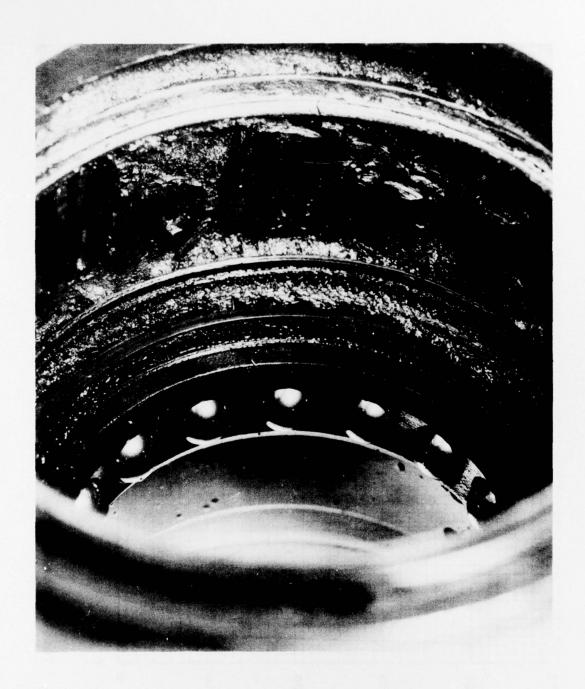
The condition of the clutch after this fracture was that outwardly the unit was intact, still on its bearing supports and able to turn freely. However, the clutch was unable to transmit torque because the rollers had been crushed, as can be seen in Figure 106. The debris seen is from the 14 rollers, which fractured upon impact. The results of the force of the impact can be seen in Figure 107. The cam lobe became brinelled and shows obvious signs of metal flow. roller retention cage, although showing some signs of distress, did not fracture, as seen in Figure 108. The snap ring that holds the oil dam was thrown from the housing and is seen in Figure 109 along with one of the bronze bushings for the carrier. This damage was considered secondary as the dam was forced to move axially out of position by the impact of the The cage of the inner support bearing closest to the roller area also fractured, as seen in Figure 110.

Figure 106. Ramp-Roller Clutch Outer Housing With Fractured Rollers, Task I Turbine Dynamic Load Test.

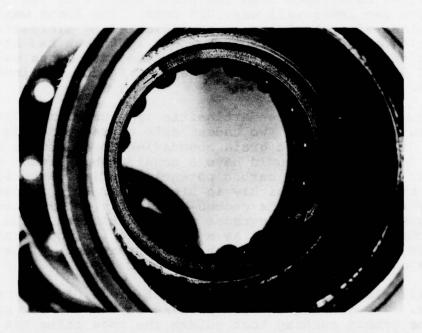
Figure 110. Inner Support Bearing, Task I Turbine Dynamic Load Test, Ramp-Roller Clutch.

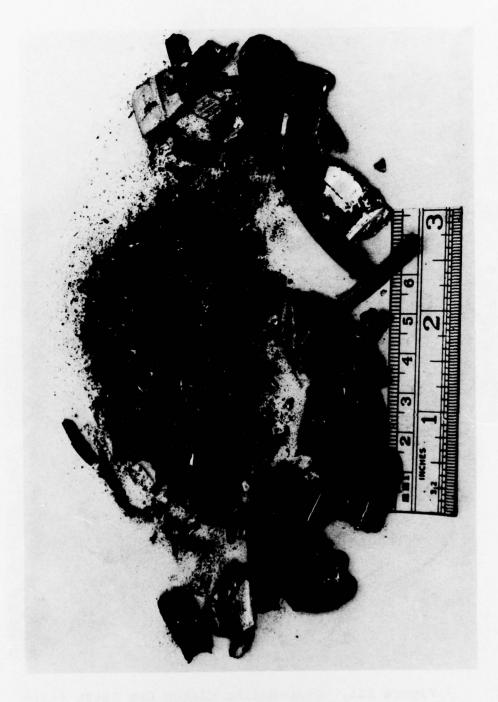
Figure 112. Fractured Roller Pieces, Task I Dynamic Load Test.

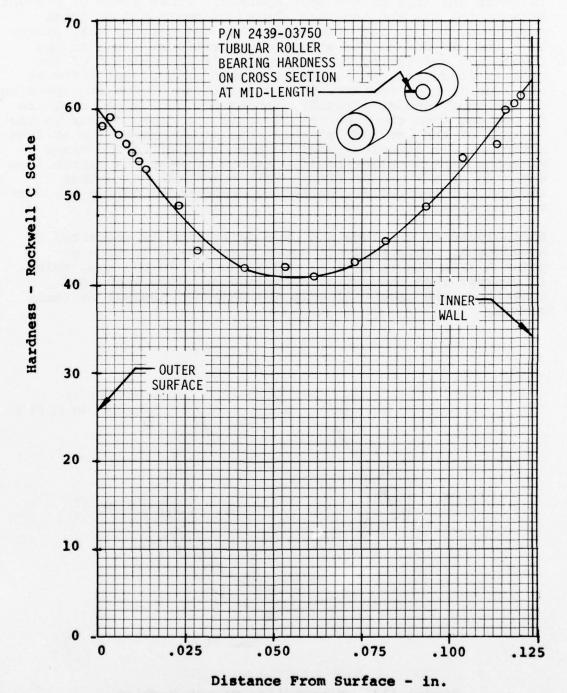
Figure 113. Hardness Versus Depth From Surface, Hollow Roller, Ramp-Roller Clutch.

The results of microhardness tests, shown in Figure 113, indicate a smooth hardness transition from case to core and an effective case depth from the outer surface of .020 inch. Depth from the inner wall was .028 inch. The inner wall was not machined after heat treat, as indicated by microstructure examination. This suggests that about .008 inch had been machined from the outer surface. Surface hardnesses were about RC 60 for the outer surface and RC 64 for the inner surfaces.

Microstructure was a fine martinsitic type with small patches of retained austenite. Two undesirable characteristics were found. Carbides were at grain boundaries to an almost continuous degree, which would have a considerable effect on strength. Lowering the carbon potential during carburizing or cooling the part more quickly in high temperature ranges is strongly recommended. The second problem is an oxidation of grain boundaries, which degrades fatigue strength. The condition occurs frequently, and as a result, it is good practice to remove .002 to .003 inch after heat treatment. This was not done on the hole of the hollow roller.

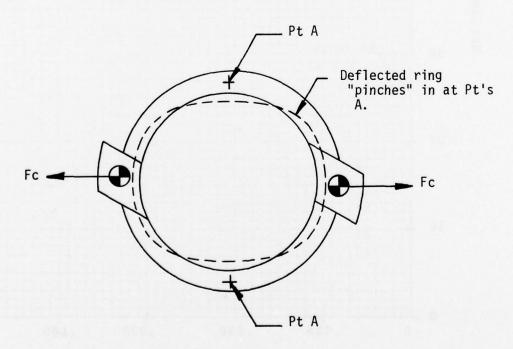
An analysis of the lugs and cage deflection is presented in Appendix A. This analysis shows that the deflection at point A (see Figure 114) is .0095 inch at 20,000 rpm, which is greater than the radial clearance of .0020 inch, and therefore, the cage will grip the camshaft journal at these points.

Figure 114. Ramp-Roller Clutch Carrier Centrifugal Effects of Lugs.

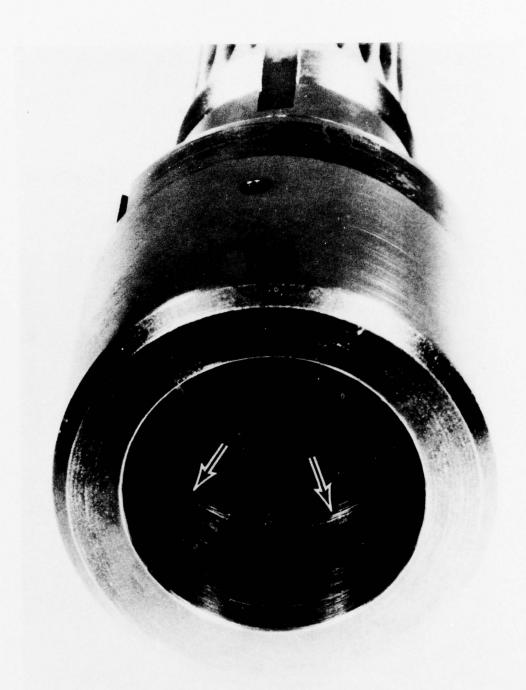
Figure 116. Scored Spring Clutch Outer Housing, Task I Turbine Dynamic Load Test.

The final clutch to be tested in the Task I dynamic load test was the spring clutch. Three cycles of dynamic load testing as previously described were completed on the spring clutch without problems. The spring clutch was disassembled after testing, and the end teaser coils were found to have experienced further deterioration in the form of silver-plate flaking. Figure 116 shows the scoring marks in the output housing incurred as a result of the silver plating particles wedging between the spring O.D. and housing I.D. during overrun. For the Task II tests, it was decided that a new spring would be used that had no silver plating on the ends so that the problem of chipped plating could be eliminated. The spring with flanged arbor used for the Task I turbine testing is shown in Figure 117.

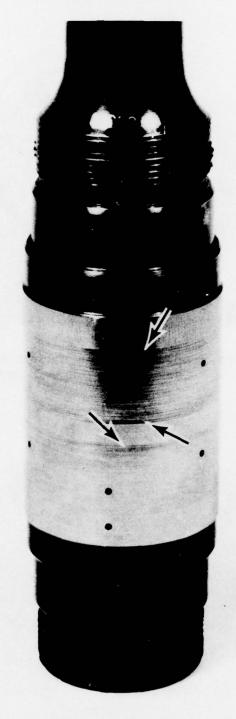
Figure 119. Sprag Clutch Inner Race After Task II Full-Speed Overrun Tests.

The first clutch to undergo the full-speed overrunning tests was the sprag clutch. Fifty hours consisting of two 25-hour segments were completed without incident at the full-speed overrun condition. Very little wear or other apparent damage was evident or measured during this test. The bandwidth of wear of a typical sprag was approximately .015 inch, which is about the same as after the differential-speed test, indicating that no wear was measured during the test. Figure 118 shows the complete sprag assembly, while Figure 119 shows the inner shaft. Most of the score marks seen on the shaft in Figure 119 were incurred during differential-speed testing.

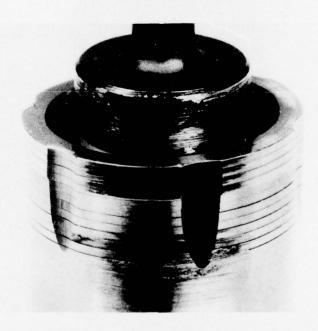
Figure 121. Spring After Task II Full-Speed Overrun Tests.

The second unit to undergo full-speed overrunning testing was the spring clutch. As with the sprag clutch, the spring clutch completed the two 25-hour tests without apparent difficulty. Figure 120 shows the output housing bore condition after testing. Note that the scoring marks are steadily spreading and are generally concentrated in an area just after the oil drain holes, indicating that the cause of the scoring is insufficient lubrication. Although the score marks continued to develop throughout the testing, they were not considered a serious problem. Operation of the clutch in both the drive mode and overrunning mode was unaffected by these The closeup of the spring shown in Figure 121 shows the area of the spring that was in contact with the score marks on the outer housing. Note that the scoring starts just where the oil drain slots taper to a solid section. The general overall condition of the spring was excellent,

with low teaser coil wear indicative of high overrunning wear life.

Disassembly of the hardware revealed that some very slight scoring and rubbing was occurring at the overrunning end of the spring at the intersection of the end of the oil slots and the output housing bore. Figure 121 shows these score marks which were essentially the same after the full-speed overrun Since the pressure at this point on the spring is less than in the teaser coils and since the velocity between the housing and spring is the same as for the teaser coils, it was deduced that the score marks were the result of poor lubrication in that area of the clutch. It should be noted that the drain holes in the outer housing are located just inside the end of the oil slots in the spring so that the lubricant will exit from the clutch prior to reaching the scored spring area. A solution to this problem would have been to extend the drain slots in the teaser coils to the center of the spring. However, the spring was not designed to withstand stress concentration effects of grooves in the more highly stressed center coil. Another solution would be the addition of a groove in the

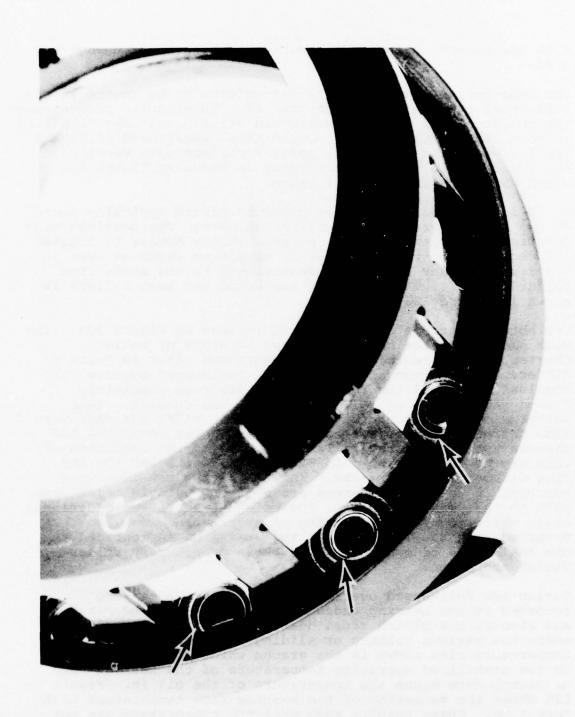
Figure 122. Roller Retention Cage End Wear After Task II Full-Speed Overrun Tests.

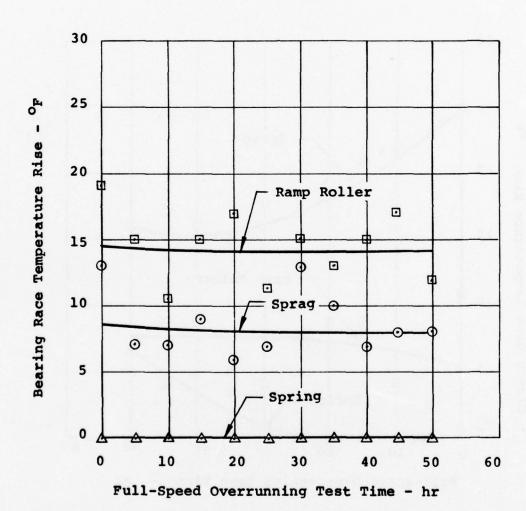
Figure 125. Bearing Race Temperature Versus Time, Full-Speed Overrun at 20,000 rpm.

During the full-speed overrun tests, temperatures were recorded at the bearing races of the overrunning bearings and also at the clutch races near the point in each clutch where the maximum rubbing or sliding was occurring. The temperature rise shown in the graphs which follow is defined as the stabilized operating temperature of the bearing race or clutch race minus the temperature of the oil in. Figure 125 shows the variation of the bearing-race temperature with test time. These results show that the temperature was not consistent throughout the test. On the other hand, clutch race temperature was fairly consistent as seen in Figure 126. On the spring clutch, race temperature appears to have two basic levels, one at approximately 0 for the first 25 hours

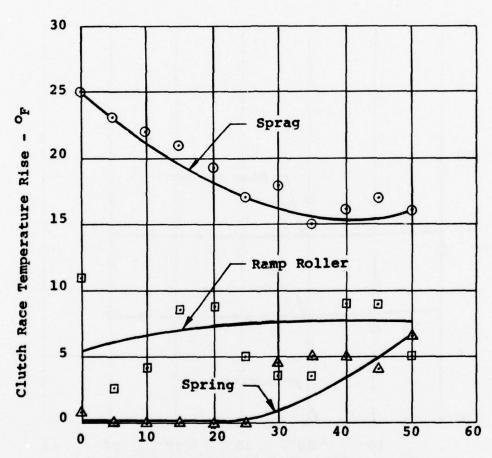
Figure 126. Clutch Race Temperature Versus Time, Full-Speed Overrun at 20,000 rpm.

and then a jump to approximately 5 degrees for the next 25 hours. This can possibly be explained by the difference in the hardware buildup after the 25-hour mark. The spring clutch was found to be very sensitive to support bearing preload (or looseness) and at times could be made to jam with heavy bearing preload. The decreasing temperature function of the sprag clutch may indicate a "wearing in" period.

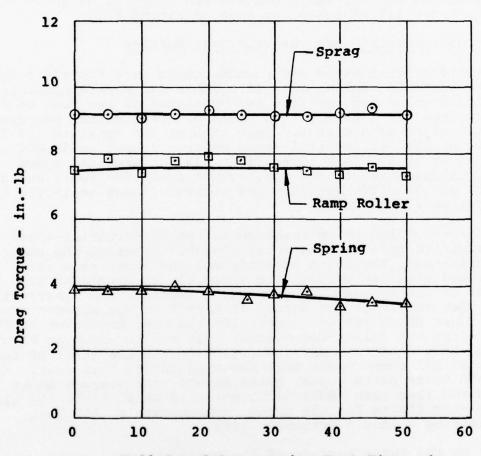
Figure 127. Clutch Drag Torque Versus Time, Full-Speed Overrun at 20,000 rpm.

Drag torque at full-speed overrun was found to be quite consistent for all clutches, as seen in Figure 127.

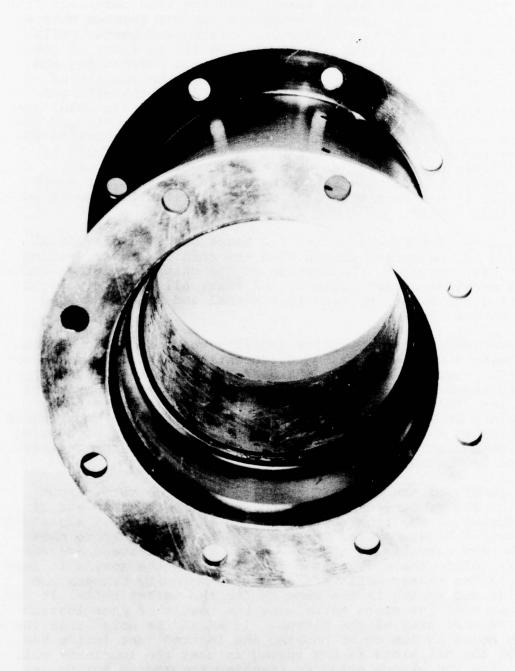
Figure 128. Sprag Clutch Outer Race, Task II, Differential-Speed Overrun Tests.

Wear on the inner surface of the sprag incurred during the differential-speed overrun test was minimal. Figure 128 shows the outer race bore. The markings seen here are of negligible depth and are randomly oriented, indicating that a small degree of relative motion had taken place between the outer race and the sprag retainer unit.

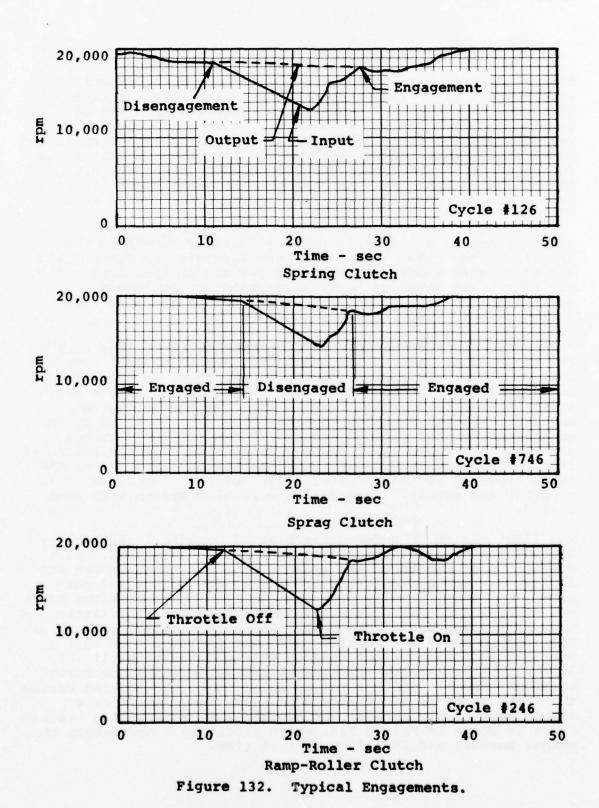
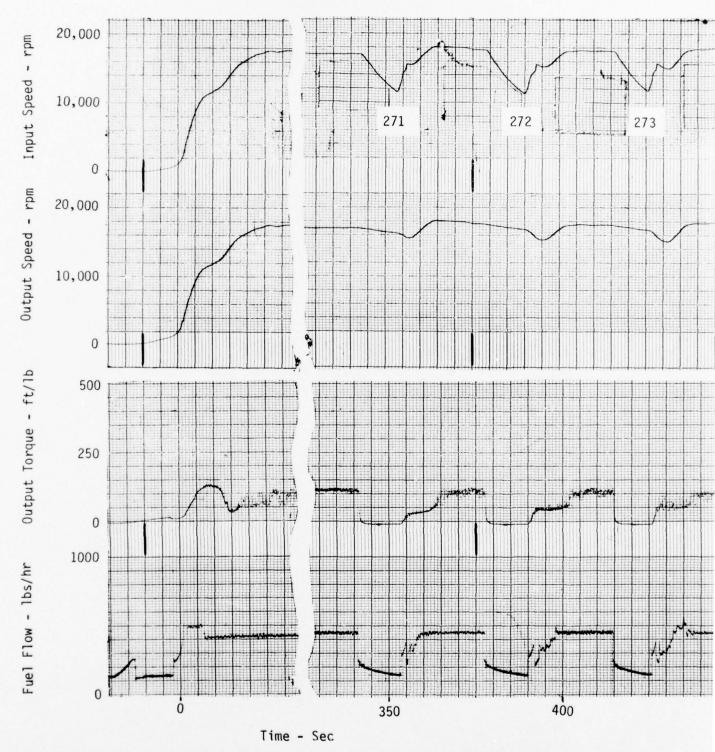
Figure 133. Typical Cycle, Sprag Clutch, Task II Dynamic Load Test.

The first clutch to undergo the Task II dynamic turbine testing was the sprag clutch. The testing was uneventful. At the completion of the test, the sprag clutch was disassembled and inspected. The typical band of wear on the sprags had not progressed significantly over what it was in the previous test, the 50-hour full-speed overrun, indicating that very little wear took place during the test. The sprag contact pattern on the inner bore of the outer housing was the result of wear on the surface finish of the housing only and was of negligible depth. The pattern is stationary, indicating that the sprag retainer assembly did not rotate relative to the housing during the test, which is as it should be. The inner shaft race showed very little change. An oscillograph record of a typical cycle is shown in Figure 133, which plots input and output rpm, output torque, and fuel flow against time.

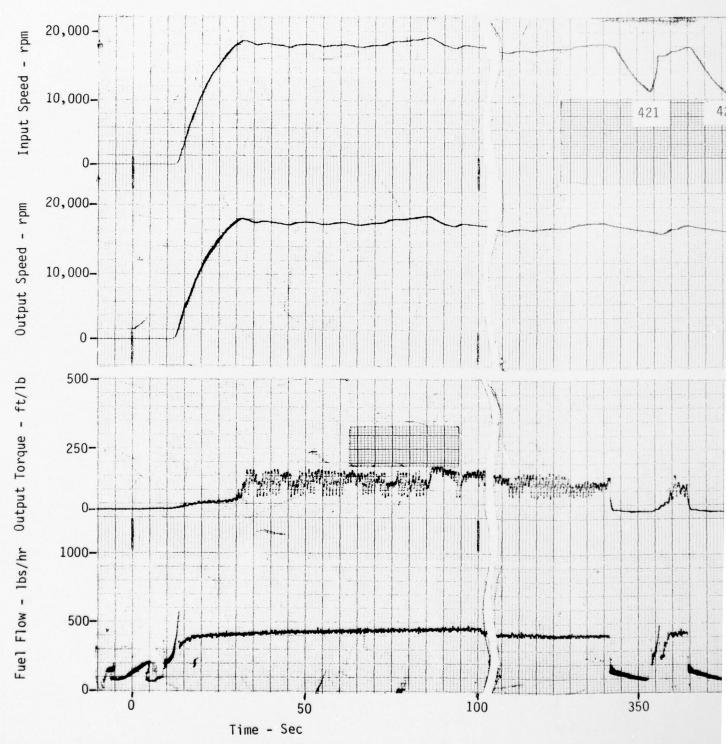
Figure 137. Typical Cycle, Ramp-Roller Clutch, Task II Dynamic Load Test.

A typical cycle for the Task II dynamic load test on the ramp-roller clutch is shown in the oscillograph record of Figure 137. It was concluded that although the ramp-roller clutch had worn throughout the test, the critical dimensions were still well within the allowable wear limits, and testing was continued.

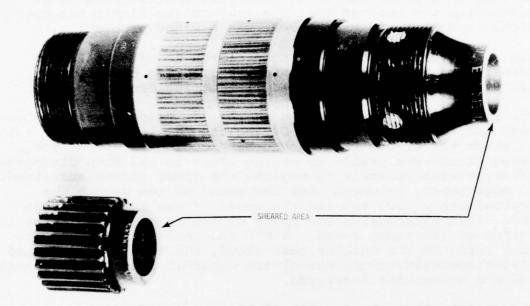
Figure 139. Sprag Clutch Inner Race at Completion of Low-Temperature Environmental Test.

Figure 139 shows the results of the overspeed engagement. The output shaft sheared in an area between the sprag inner race and the spline connection. The fracture is typical of that experienced when a high-strength steel part fails in pure shear. The inner race was found to be in good condition from a dimensional standpoint, measuring 1.7497/1.7499 and 1.7502/1.7504 across each spragway. A hardness check found the hardness to be Rockwell "C" 62, which is the mean of the 60 to 64 drawing specification. Visually, the two spragways were in poor condition due to the presence of numerous high-load patterns that indicate slight brinnelling and galling. The number and locations of these high-pressure patterns suggest that the clutch bounced in and out of engagement approximately six times prior to shaft shear.

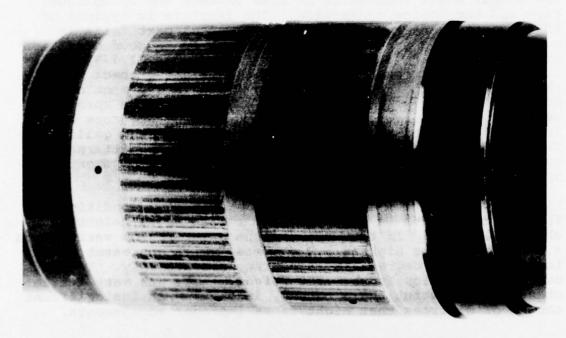
Figure 140. Typical Sprags at Completion of Low-Temperature Environmental Test.

Figure 140 shows the sprags, which were in poor condition. The contact points in the high load region (.338 height) showed distress. In this region, the strut angles varied from 4.7 degrees to as high as 5.3 degrees, which represent increases of .5 degree and .8 degree, respectively. In the overrunning region at the .328 height, there was very little change in the strut angle curves, indicating an insignificant amount of distress that might cause improper engagements.

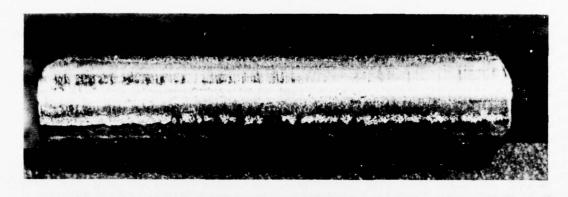
Figure 141. Sprag Clutch Outer Race at Completion of Low-Temperature Environmental Test.

Figure 141 shows the outer race, which was found to be in poor condition both visually and dimensionally. The diameter

across the spragway measured 2.412/2.414 inches, indicating a permanent yield of .005/.007 inch. A hardness check showed that at the spragway, the hardness measured Rockwell C 31-32, which is well below drawing specifications of Rockwell C 60-This was caused by an error in heat-treating procedures when the housing was carburized but not placed back in the furnace for rehardening. A check of all the sprag clutch outer races showed that they were all in a similar state of heat treatment. Visually, there were eighteen high-pressure load patterns on each spragway in the form of brinnel marks, which measured approximately .002 inch deep. Although the outer housing was not hardened, as discovered during the coldoil test, the housing showed no apparent signs of distress during all previous tests. Brinelling was less than .0001 inch prior to the cold test. Thus, the unhardened condition was not felt to be a contributing factor to the overspeed engagement.

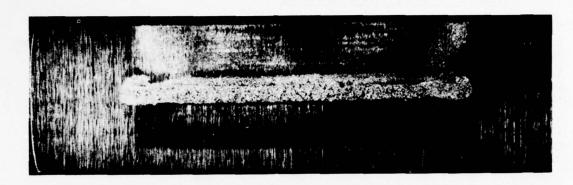
Figure 142. Typical Cam Flat at Completion of Dynamic Cyclic Torque Test.

The ramp-roller clutch was the second clutch to undergo dynamic-cyclic testing. As with the sprag clutch, no problems were encountered during the testing, which went very smoothly. Post-test inspection and measurement did not reveal any abnormalities. The roller end wear did not progress during this test since the rollers were locked and did not rotate relative to the cage. A typical cam flat is shown in Figure 142.

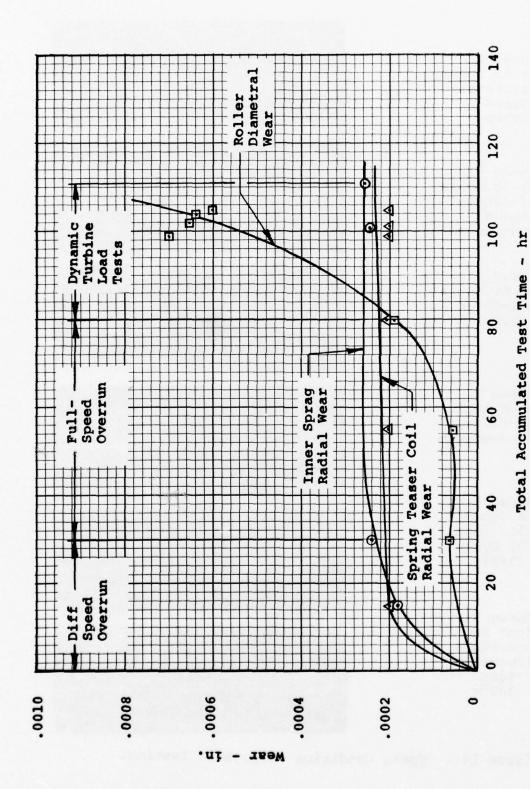
Wear Versus Time, Spring, Sprag, and Ramp Roller Clutches. Figure 143.

Since the dynamic-cyclic test completed all of the dynamic testing in the program, it is informative to examine results obtained from the beginning of Task II dynamic testing to the end. Figure 143 depicts the key wear measurements for the clutches taken throughout the Task II tests.

For the spring clutch, the key wear parameter is the radial wear of the teaser coils on the overrunning (sliding) end of the spring. This measurement was obtained with a micrometer and is an average of measurements at two different positions, 90 degrees apart. These measurements were taken at the conclusion of each test.

On the sprag clutch, the key measurement was the bandwidth of a typical sprag; in this case, sprag number 1. To measure the average bandwidth, a photograph was taken of the inner surface of sprag number 1 showing the bandwidth of wear after each test. From the photograph, a planimeter was used to measure area, and using appropriate scale factors, the average width was obtained by dividing the area by the sprag length. The average width of the wear band was then converted to depth of wear using the appropriate geometry of the sprag and the inner race. The depth of wear is plotted in Figure 143.

In the ramp-roller clutch, the key wear measurement was roller diameter. This was measured with a micrometer after each test. It is seen in Figure 143 that the roller clutch wear increased significantly during the dynamic load tests. A projection of the wear curve for the ramp-roller clutch will not give a long clutch life, whereas the projections of the sprag and spring clutch wear parameters would indicate long clutch overrunning lives.

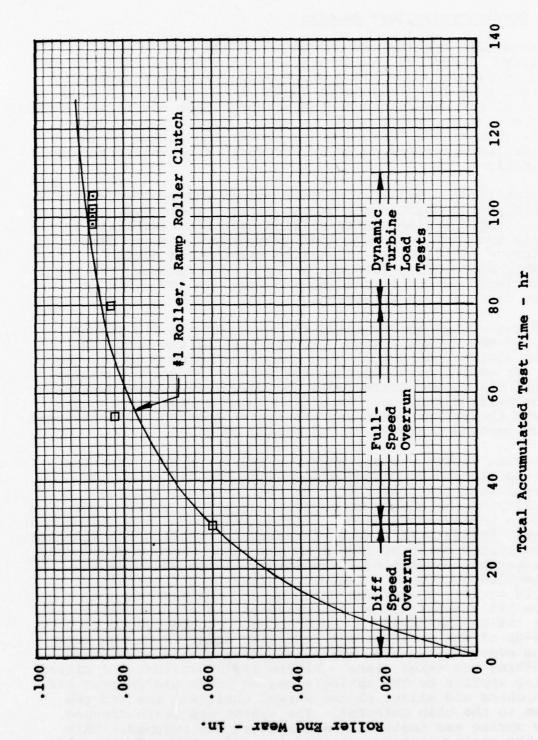
Figure 145. Roller End Wear Versus Time, Ramp-Roller Clutch.

The rollers of the ramp-roller clutch incurred a peculiar type of wear throughout the testing on the end faces of several of the rollers. The roller with the highest wear was roller number 1. The next worst case was roller number 2, which only experienced approximately half of the wear of roller number 1. A plot of roller number 1 end wear is shown in Figure 145.

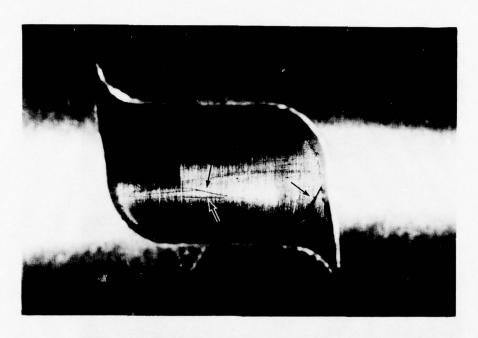
Figure 146. Spring Clutch Center Coil Hole, Static-Cyclic Test.

The spring clutch was operated for 753,860 cycles when the test was stopped by clutch slippage to the limits of the rotary actuator's travel (100 degrees maximum) and the inability of the clutch to sustain reapplied torque load. spring's teaser coils on the overrunning end of the clutch had "jammed" against the flange of the arbor, causing the diameter of the teaser coils to reduce to the point where torque could no longer be transmitted. The spring clutch was cleaned, reassembled and testing resumed. After an additional 744,020 cycles, a chip was detected and the test stopped. Figure 146 shows fine metallic slivers and light metallic chips inside the spring's center slot. Figure 147 is a close-up of the spring arbor dowel-pin hole. Note the burr on the edge of the hole, which indicates that a high degree of working has taken place. Figure 148 shows that the silver plating applied to the spring's teaser coils had chipped off. These chips and silver pieces worked their way through the system to the chip detector. The system was again cleaned, a new spring was installed, and testing was resumed. This time the spring clutch sustained 133,050 cycles of operation before the limit of the actuator was reached. Repeated

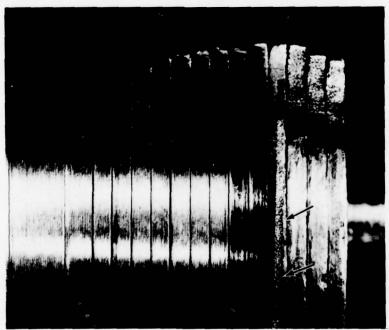
Figure 148. Spring Teaser Coils, Static-Cyclic Test.

attempts to reengage the clutch failed, and the clutch was disassembled and inspected. As in the first spring clutch test, the spring was unable to drive because the spring had "bunched up" against the flanged arbor and had jammed itself tightly against the flange, rendering drive-mode operation impossible. Figure 149 illustrates the jamming condition. Note the staggering of the end teaser coils with the progressively increasing offsets towards the free end. ing each cycle of vibratory torque application, the spring had crept towards the flange. In operation on the helicopter, each time the engines are turned off after a flight, the spring clutch would return to its arbor and free itself of this jamming effect. However, because of the possibility of loss of torque, the flanged arbor design was abandoned in favor of the original design with slotted spacer, and all Task II dynamic testing was conducted with the slotted spacer design. In this design, the teaser coils will move in unison with the output housing, and the tendency to creep is reduced.

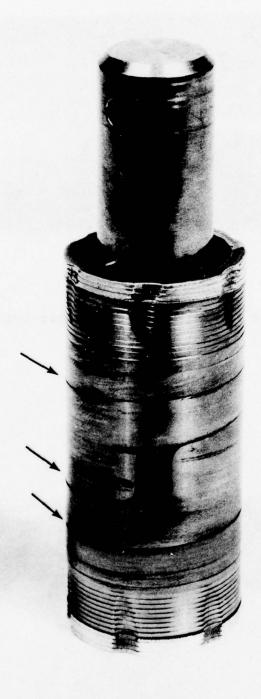
Figure 150. Spring at Completion of Static-Cyclic Test.

An additional static cyclic test was conducted with the spring clutch in its original configuration, with the slotted This test was conducted for 1,864,750 cycles before termination by loss of torque drive. Inspection showed that the spring had again crept towards the bronze spacer and had, in fact, wedged itself into the spacer, leaving an impression .012 inch deep where the end of the spring touched the washer. The condition of the spring is shown in Figure 150. The dark lines seen on the center coil sections are the result of permanent yielding. An analysis of the stresses present in the spring for the torque load being applied indicates that the spring should not yield at even twice the load tested. The conclusion was that the torque was not being applied uniformly to the spring clutch assembly, and since the spring clutch design is sensitive to housing bore misalignment, the loads induced in the spring were magnified. It was decided that the final configuration tested, i.e., the design with the bronze spacer between the output housing and the spring's overrunning end, would be used for all further testing.

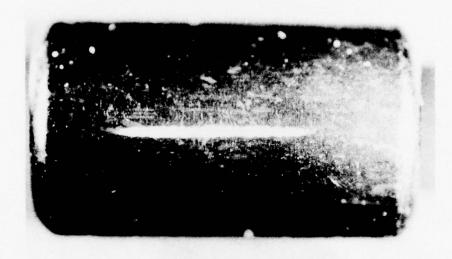
Figure 151. Roller at Completion of Static-Cyclic Test.

The second clutch to be tested in the static-cyclic test was the ramp-roller clutch. It was operated at a torque of 9450 ± 1000 inch-pounds for 10,000,000 cycles without difficulty. Inspection of the roller clutch components after the test did not reveal any abnormalities. Figure 151 shows a typical roller at the completion of testing. The light line seen on the roller was the result of contact between the roller and the outer housing in a single continuous position and was of negligible depth. The camshaft, as shown in Figure 152, was in good condition. The brinell marks seen on the flats were of negligible depth.

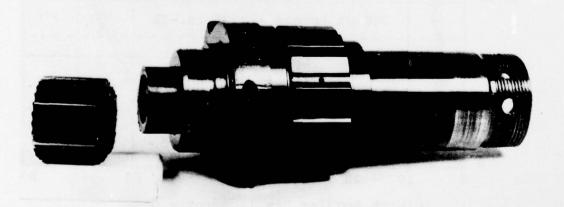
Figure 155. Camshaft, Static Overload Test.

The second clutch to undergo static overload testing was the ramp-roller clutch. The roller clutch sustained a torque load of 18,500 inch-pounds but fractured at 18,800 inch-pounds during the final load increment. The fracture occurred at the inner race camshaft through the cross section adjacent to the drive spline. Figure 155 shows the camshaft with the fracture. This type of fracture is typical for a high-strength steel part subjected to pure shear. The calculated strength of the section was in close agreement with the test results. Prior to total fracture, appreciable yielding of the shaft was evident at torque levels exceeding 17,500 inch-pounds.

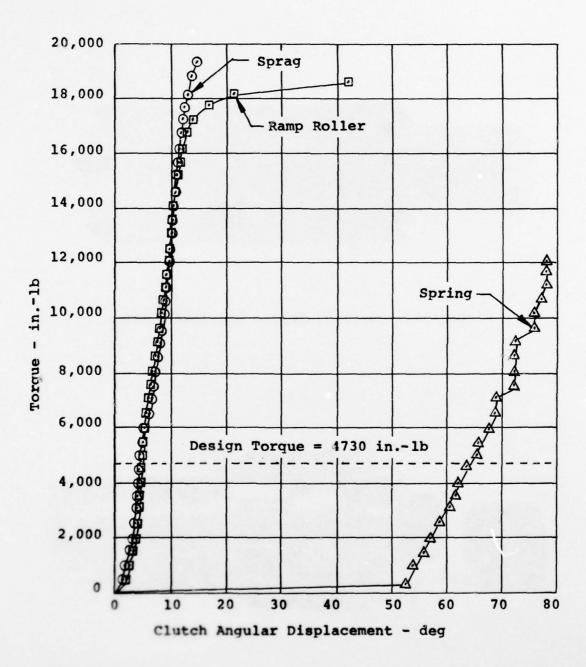
Figure 156. Static Torque Versus Angular Displacement, Spring, Sprag, and Ramp-Roller Clutches.

The final clutch to be tested in the static overload test was the sprag clutch. The sprag clutch sustained 18,900 inchpounds of torque without evidence of yielding or slipping. Figure 156 is a plot of torque versus angular displacement for the three clutches tested. The yielding of the roller clutch is plainly seen in this curve. The sprag clutch geometry is identical to the roller clutch geometry in the area of fracture. That is, the spline is the same, the outside and the inside diameters of the adjacent area are the

same, and the material and the heat treatment are the same. The conclusion can therefore be made that the sprag clutch was also on the verge of yielding in the area adjacent to the spline. In fact, the beginning of the change in slope of the sprag clutch (beginning of yield) can be seen in Figure 156, starting at approximately 18,000 inch-pounds.

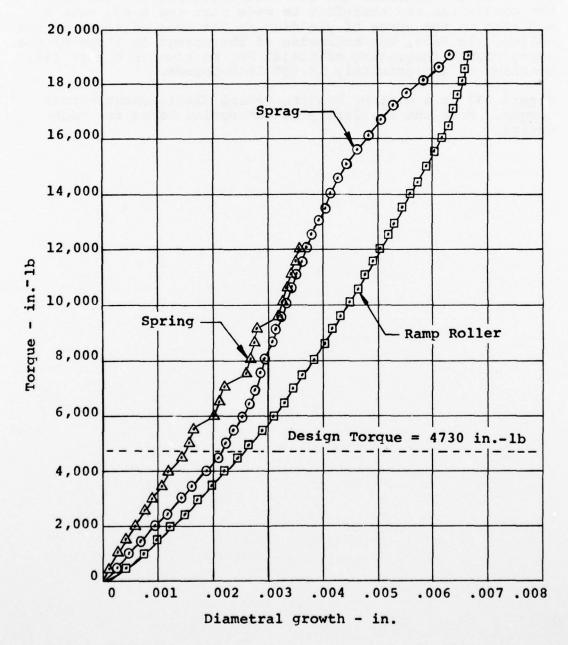
Figure 157. Static Torque Versus Radial Displacement, Spring, Sprag, and Ramp-Roller Clutches.

Figure 157 is a plot of housing radial displacement versus torque. Note the similarity of the spring rates for each design.

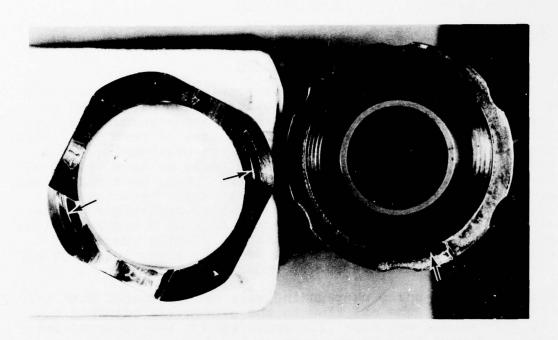
At the conclusion of the spring clutch's speed rundown test, a 5-hour full-speed overrun test was conducted with the flow at the 200% design condition of 1.6 gpm. Disassembly and inspection after this test showed slight indications of wear on the teaser coils. A small amount of wear was also present on the end face of the spring and on the corresponding section of the bronze washer that separates the spring from the output-housing end face. The condition of these parts after the first 5-hour run can be seen in Figure 56.

Figure 56. End View of Spring and Bronze Bushing at Completion of 5 Hours of Full-Speed Overrunning, Task I.

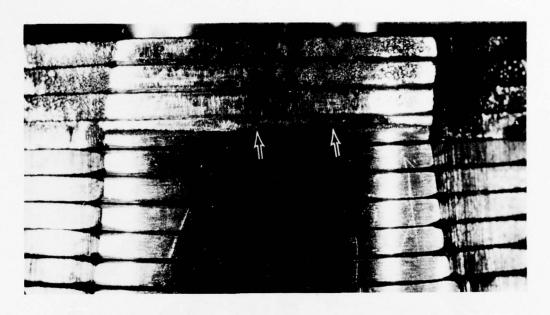
The spring clutch was reassembled, and a second 5-hour full-speed overrun test was conducted at the 100% design flow condition of .80 gpm. At the conclusion of this 5-hour test, the spring clutch parts were examined, and although no distress signals were evident during the test, the parts were found to have some signs of deterioration. Figure 57 shows the condition of the spring teaser coils, which show areas of missing plating. The plating is silver and was applied to the teaser coils as a wear barrier for overrunning. The plating that had chipped then proceeded to flow with the oil in an attempt to exit from the clutch. During this process, the center section of the spring along with several areas of the bore of the output housing sustained scoring marks as shown in Figure 58. The chipping was considered a minor problem, and it was decided to clean the parts and continue testing.

Figure 57. Spring Teaser Coils on Overrunning End After Full-Speed Overrunning Test, Task I.

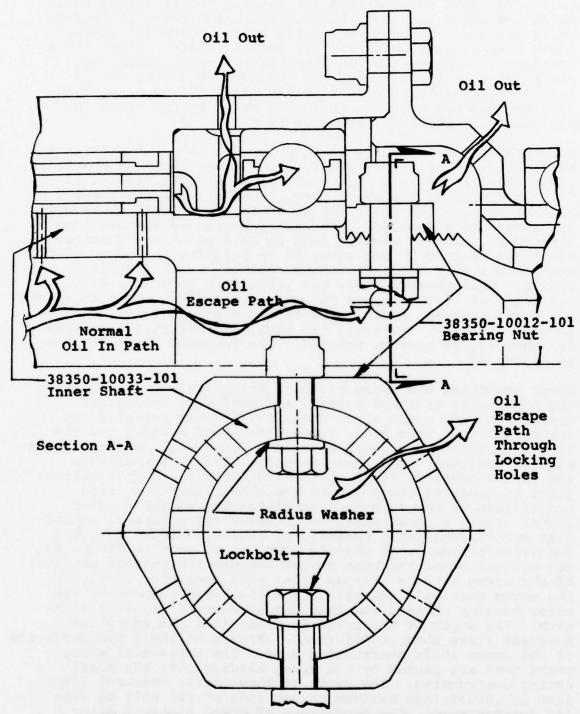
Figure 61. Lubricant Escape Path in First Sprag Clutch Design Found During Task I.

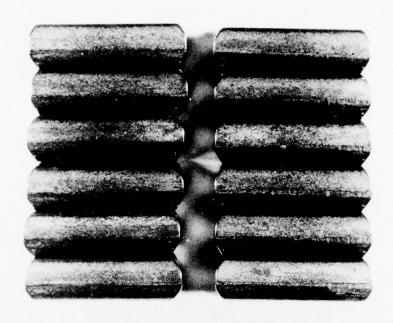
Figure 63. End View of Randomly Selected Sprags Showing Wear Incurred During Full-Speed Overrunning Test, Task I.

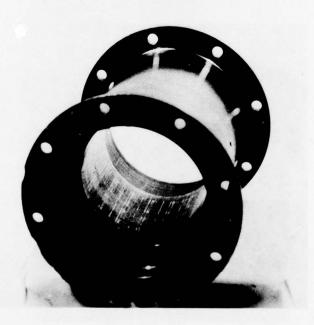
The sprag clutch's 100% flow condition was established as .80 gpm and was the same as the spring clutch's flow, as shown in Table 23. At the conclusion of the 5-hour test run, the sprag clutch was disassembled and inspected. It was found that the wear on the sprags was higher than was to be expected for so short a duration of overrunning. Figure 59 is a photograph of sprag numbers 1, 7, 19, and 31, which were chosen at random and represent an average wear condition. The average band width of the wear was in the order of .015 inch. Also evident was wear on the inner shaft and the drag strips of the sprag unit, as shown by the photographs of Figure 60. The outer shaft also shown in Figure 60 displayed sprag-contact-area marks, which were of negligible depth.

Figure 64. Sprag Clutch Outer Shaft Bore After Full-Speed Overrunning Test, Task I.

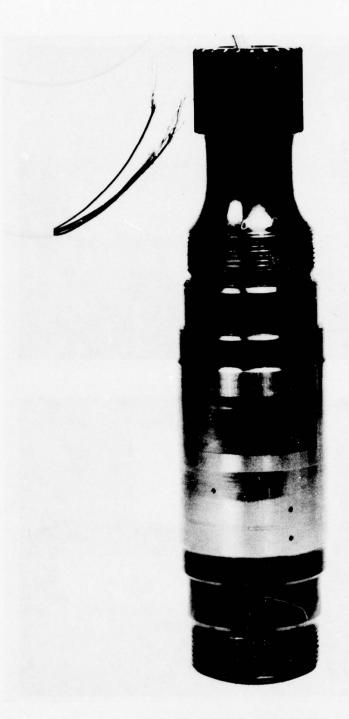
Figure 65. Sprag Clutch Inner Shaft After Full-Speed Overrunning Test, Task I.

After reworking the sprag clutch's inner shaft O.D., plugging the holes with silicone rubber, and replacing the entire sprag unit with a new sprag unit, testing was restarted at the beginning. This time, the entire speed rundown and the five-hour full-speed overrun at 100% flow tests were conducted without incident. The sprag inner-shaft race temperature was in the order of 212°F at the 100% flow of .8 gpm, whereas prior to blocking the holes in the shaft, the inner race temperature in the same flow condition was in the area of 280°F. Thus, a substantial improvement was obtained. Sprag wear was substantially reduced, as shown in Figure 63. The condition of the outer shaft's bore can be seen in Figure 64. New contact areas had been formed because the angular position of the sprag unit is changed after each assembly. Normally, the sprag unit will not change position with respect to the outer housing because the drag bands restrict relative rota-The depth of the marks is negligible and cannot be measured (less than .00005 inch). Figure 65 shows the condition of the inner shaft overrunning area. The tangential score marks seen are caused by the sprag sliding over the shaft during overrunning. The depth of these marks measured .0002 inch to .00035 inch maximum on one side of the unit to zero 180 degrees away. The conditions of sprag number 1 after 5 hours and after 10 hours are shown in Figure 66.

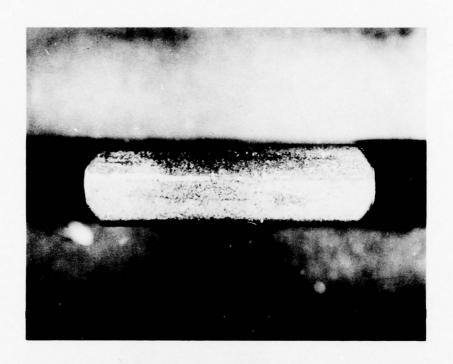
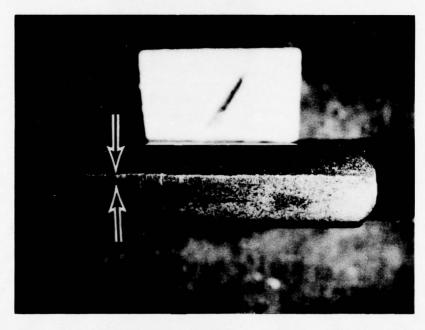
Figure 66. Number 1 Sprag After 5 Hours (Above) and After 10 Hours (Below) of Full-Speed Overrunning, Task I.

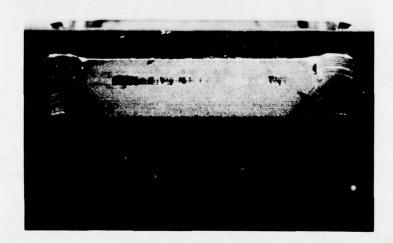
Figure 68 shows a typical roller and a typical front edge of a slot in the roller-retention cage, while Figure 69 is a photograph of the cam shaft. The cam shaft flats show no evidence of wear of any kind.

Figure 68. Typical Roller and Roller Slot in Cage After 5 Hours of Full-Speed Overrunning, Task I.

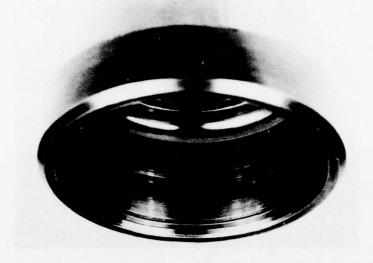
Figure 70. Typical Roller at Completion of Full-Speed Overrunning Test, Task I.

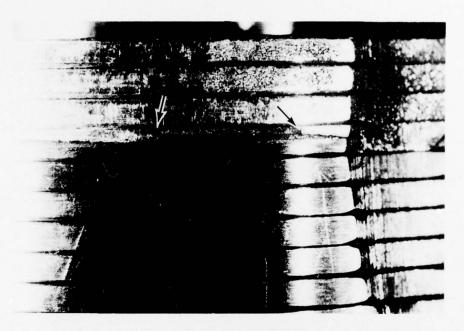
Disassembly and inspection showed that some of the silver plating had chipped off the teaser coils of the clutch. These loose pieces of silver, in attempting to flow out of the clutch through the oil, had wedged between the output housing bore and spring outside diameter, causing the momentary increase in drag. Another factor that may have contributed to the false engagement was the drag on the end face of the teaser coils. Figure 81 shows the condition of the teaser coils after the test, while Figure 82 shows the output housing bore with some additional score marks to those incurred during the full-speed overrun test.

Figure 81. Spring Teaser Coils After 3 Hours of Differential-Speed Overrunning, Task I.

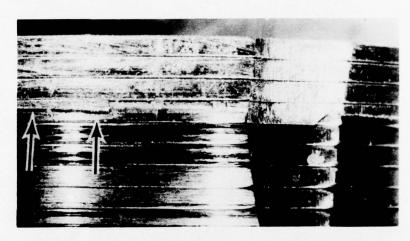
Figure 82. Spring Clutch Output Housing After 3 Hours of Differential-Speed Overrunning, Task I.

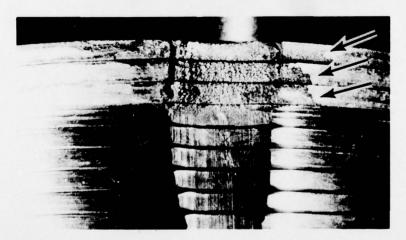
Figure 83. Spring Teaser Coils After Differential Speed Overrunning Test, Task I.

component to plate. Note the "bubbling" effect in the spring's teaser coil lubrication slots. This is an indication of poor plating quality. The effect of the silver-plating chipping was that in general the output housing sustained the greatest damage in the form of score marks on the inner bore, whereas the spring outside diameter was relatively free from scoring, as seen in Figure 84.
